TRAINING REPS

ATF Analysis of FF Nathan Flynn LODD

B.C. Scott Ebbert

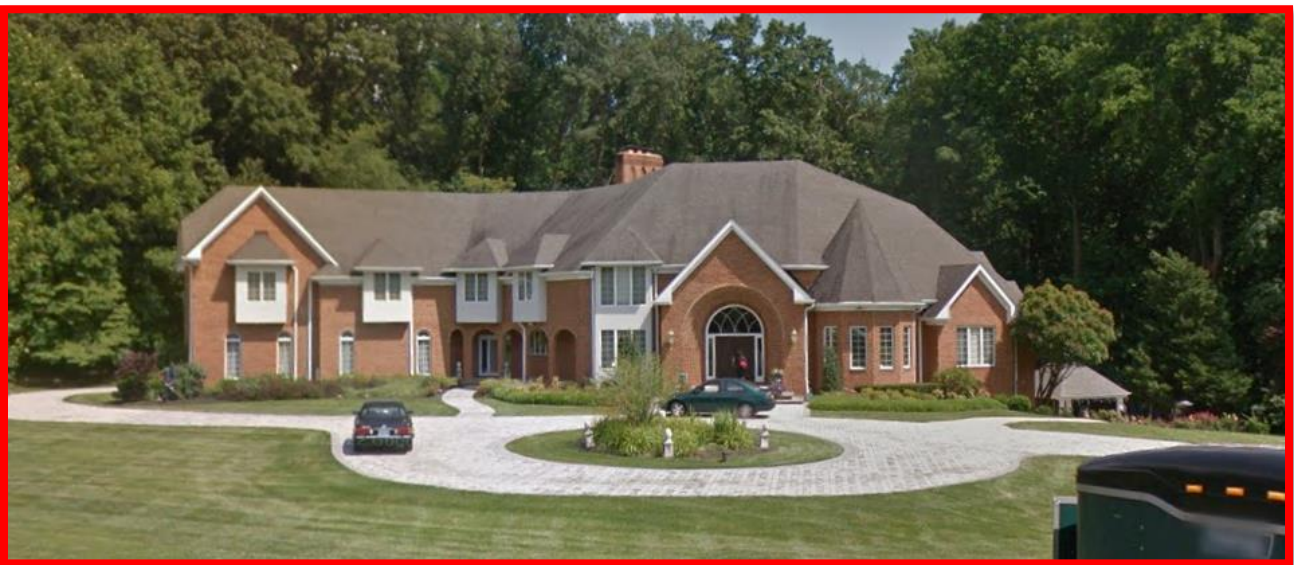
- The residence at 7005 Woodscape Dr. in Howard County consisted of 8,400 sq. ft. of open living space. Type V construction.
- The fire developed in a crawl space that was between the basement floor and first floor. A visual of the basement revealed no fire while crews entering the first floor initially determined the fire to be in the basement.

- The effects of a ventilation unidirectional flow path that existed from the basement door (inlet), through the burning crawl space and up through the living room/mud room door caused firefighters to initially see flames on the first floor and incorrectly believe the fire originated and was located in the first floor living room.

- The wood floor joists and wood sheathing that supported the flooring system burned away in the area of the CSST arc hole and resulted in structural collapse of the massive tile flooring system into the burning crawl space.

1. **The extremely large volume of the residence allowed for a well-developed fire, despite light smoke showing on the exterior.**
2. **The elevated fire located in the basement crawl space created atypical smoke filling conditions in basement.**
3. **A ventilation flow path existed from the basement door (inlet), through the hole in the crawl space and out the first-floor mud room door (outlet). This flow patch created untenable conditions on the first floor during the MAYDAY.**
4. **The corrugated Stainless Steel Tubing (CSST) location and its relationship with the structural collapse.**
5. **An additional lightning induced CSST LODD incident (Capt. Josh Laird) occurred just three years later.**

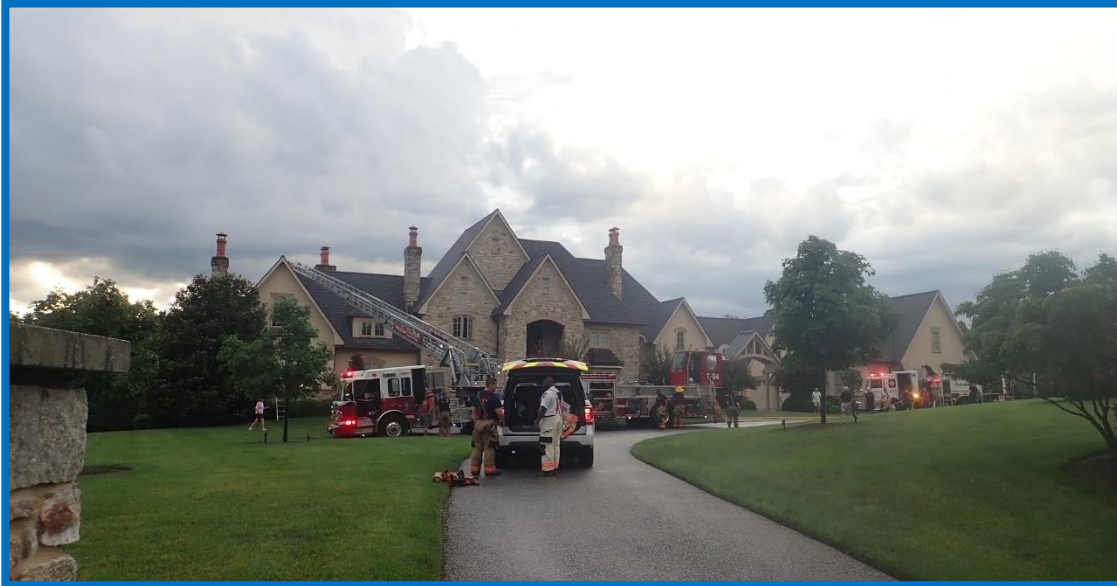
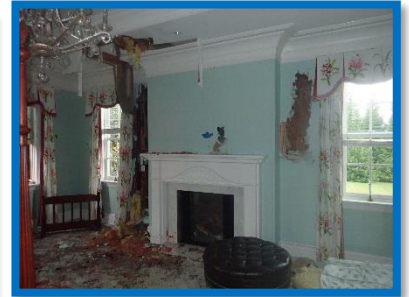
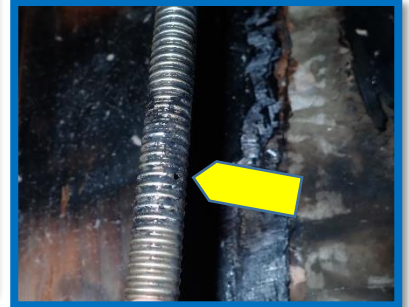
- The residence at 4 Timerpark Ct. (Box 17-15) is in excess of 12,000 sq. ft. Type V construction.
- The fire originated within the wall space of a bedroom on the first division. Smoke traveled up the wall cavity and into an attic space, eventually showing near the peak on the exterior.
- The location of the arc hole in CSST resulted in a sustained flame within the wall cavity, causing damage to wooden wall studs and sheathing. Time and the aggressive and thorough investigation by crews contained the fire before it extended into the attic space.

Baltimore County is no stranger to fires involving CSST. On July 18, 2022 the cause of a dwelling fire in Cockeysville was attributed to CSST failure following a severe storm. The circumstances were eerily similar to those of the Flynn and Laird LODDs: A large “mega-mansion” style dwelling, light smoke conditions on the exterior, in a non-hydranted area, after a lightning intense storm. Luckily, the fire occurred within a wall cavity and was quickly detected by the owner.
